US Army Corps
of Engineers
Waterways Experiment
Station

Technical Report CERC-95-9
July 1995

Monitoring of the Yaquina Bay Entrance North Jetty at Newport, Oregon; Summary and Results

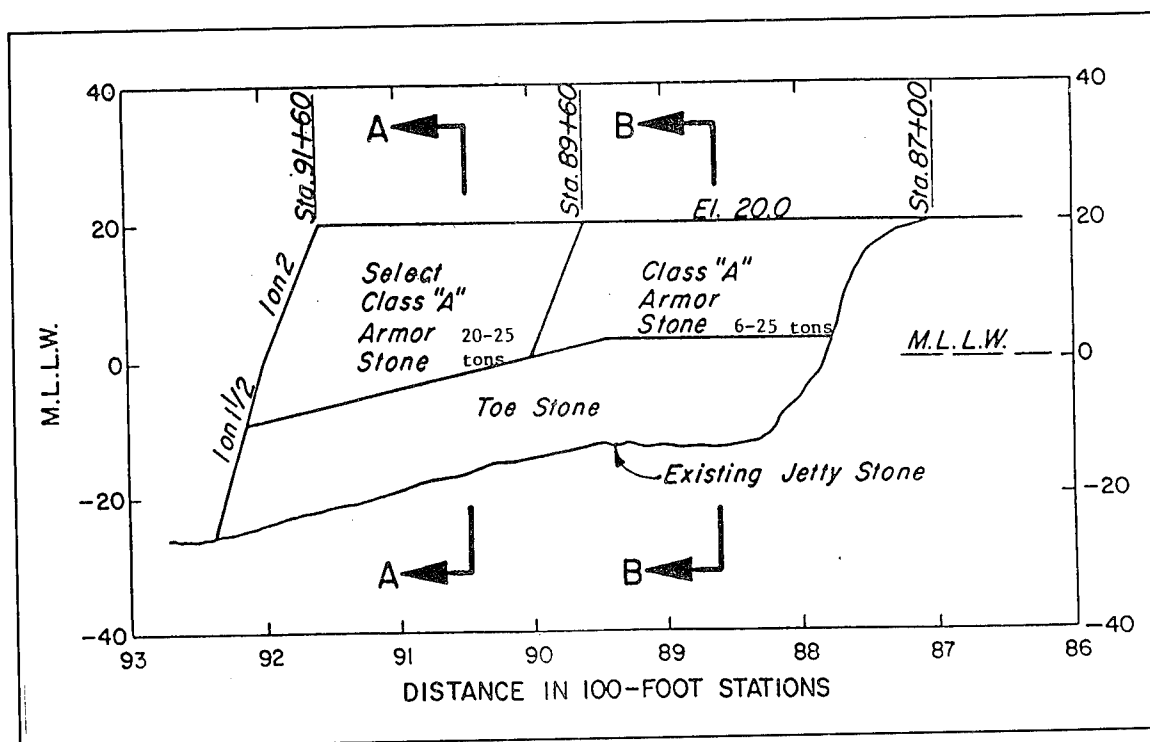
Figure 59. Yaquina Bay north jetty 1978 rehabilitation jetty profile

The north jetty in the model was constructed according to the cross sections as given in Figures 59 and 60. (Note that jetty station numbering differs from the scheme used in the MCCP study.) No information was available on the condition of the bedding layer and remnants of the 1966 construction in

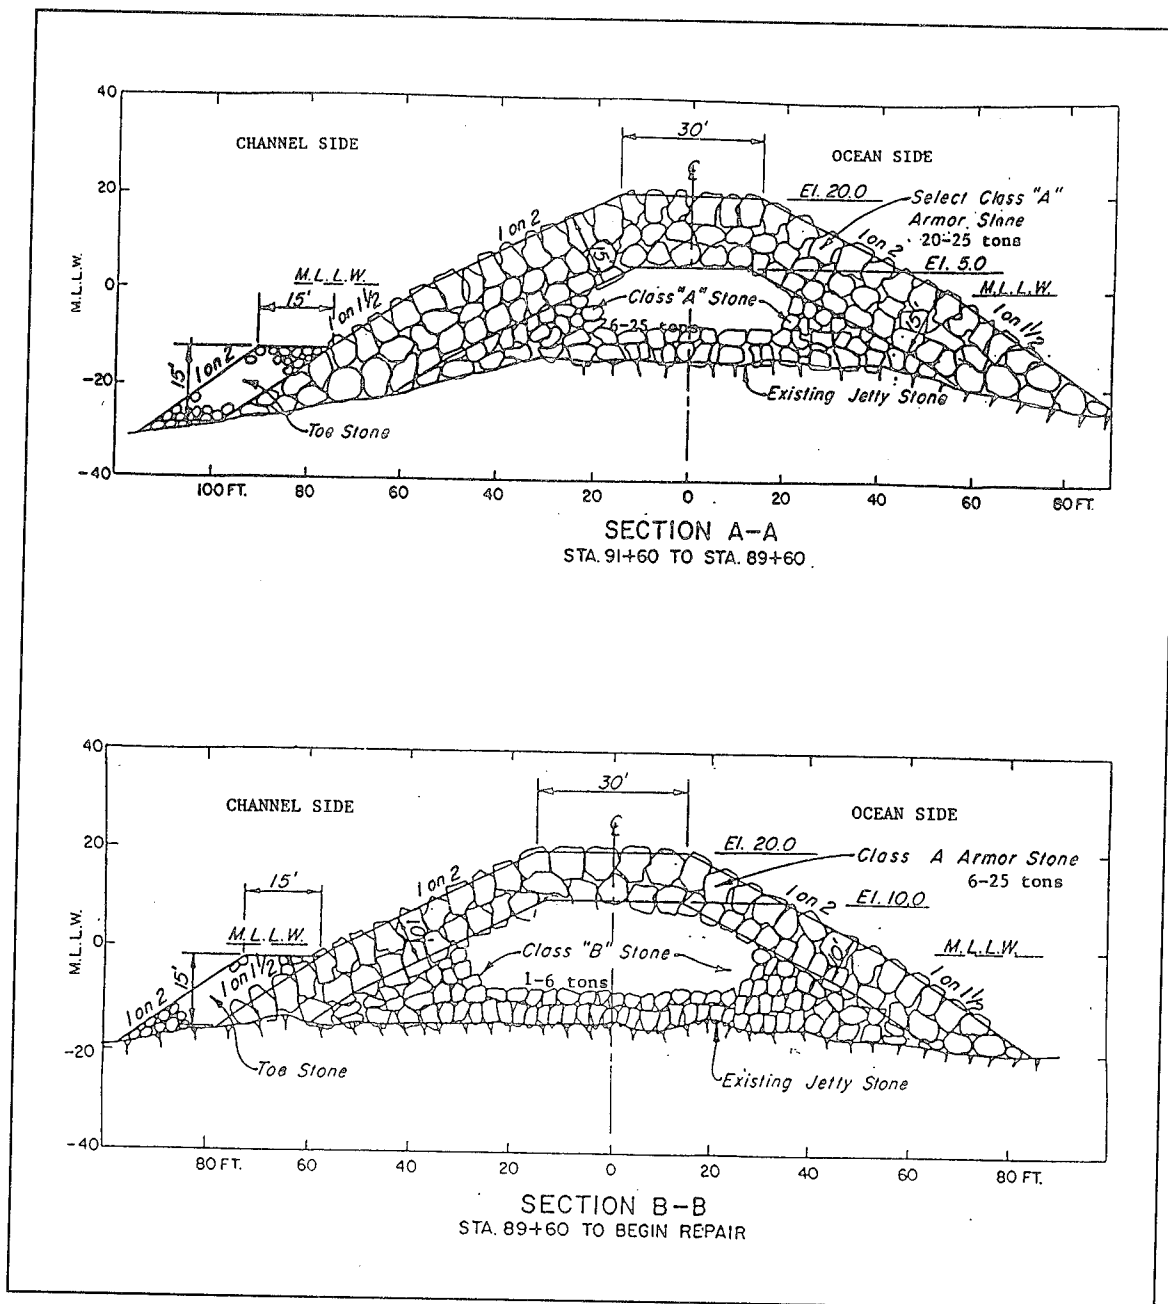
Figure 60. Yaquina Bay north jetty 1978 rehabilitation jetty cross section

the portion of the jetty that had been damaged before the 1978 rehabilitation. Therefore, bedding and core materials were placed in a manner similar to a new construction, but with a wider base. The two layers of select class "A" stone used as the primary armor were specially shaped parallelepiped stones with a maximum length between two and three times the shortest dimension. Scaling for the 1:45 scale model resulted in average select "A" class 18-tonne (20-ton) armor stones in the prototype being represented by model armor stones with a mass of about 0.2 kg (0.44 lb). These model armor stones were handmade to Portland District specifications. Above mllw, stones were placed with their long axis perpendicular to the jetty slope. Below the waterline, stone placement was random. Special placement of the slab-like armor stones results in increased stability compared to randomly placed stone. Figure 61 shows a photograph of the completed north jetty model structure.

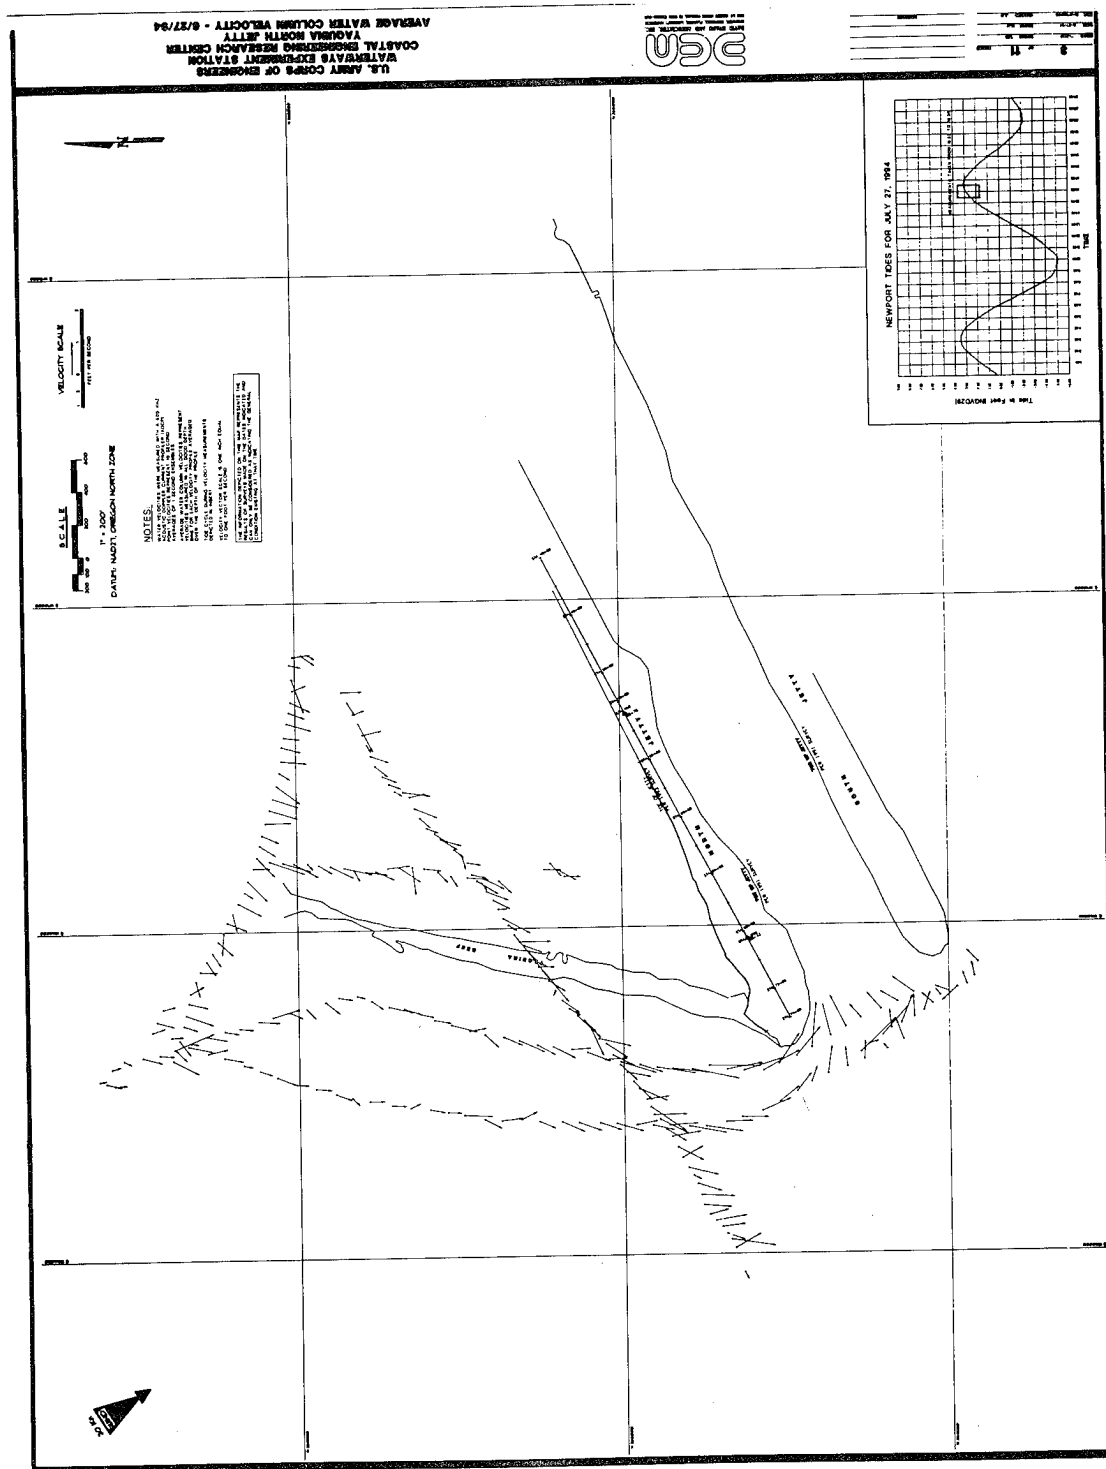
Figure 67. Depth-averaged current velocity vectors at Yaquina Bay north jetty (27 June 1994)

The currents shown on Figure 67 indicated a fairly uniform southerly longshore current of about 20-30 cm/s (0.7-1.0 ft/s). Closer to the north jetty, flow was directed seaward parallel to the jetty, but magnitudes on this trackline were not very large. From the data it cannot be determined if higher seaward velocities were present closer to the north jetty. Current magnitude increased close to the jetty tip due to flood currents in the entrance channel. Despite moderately rough conditions, flow velocities measured on June 27 did not appear to be out of the ordinary.

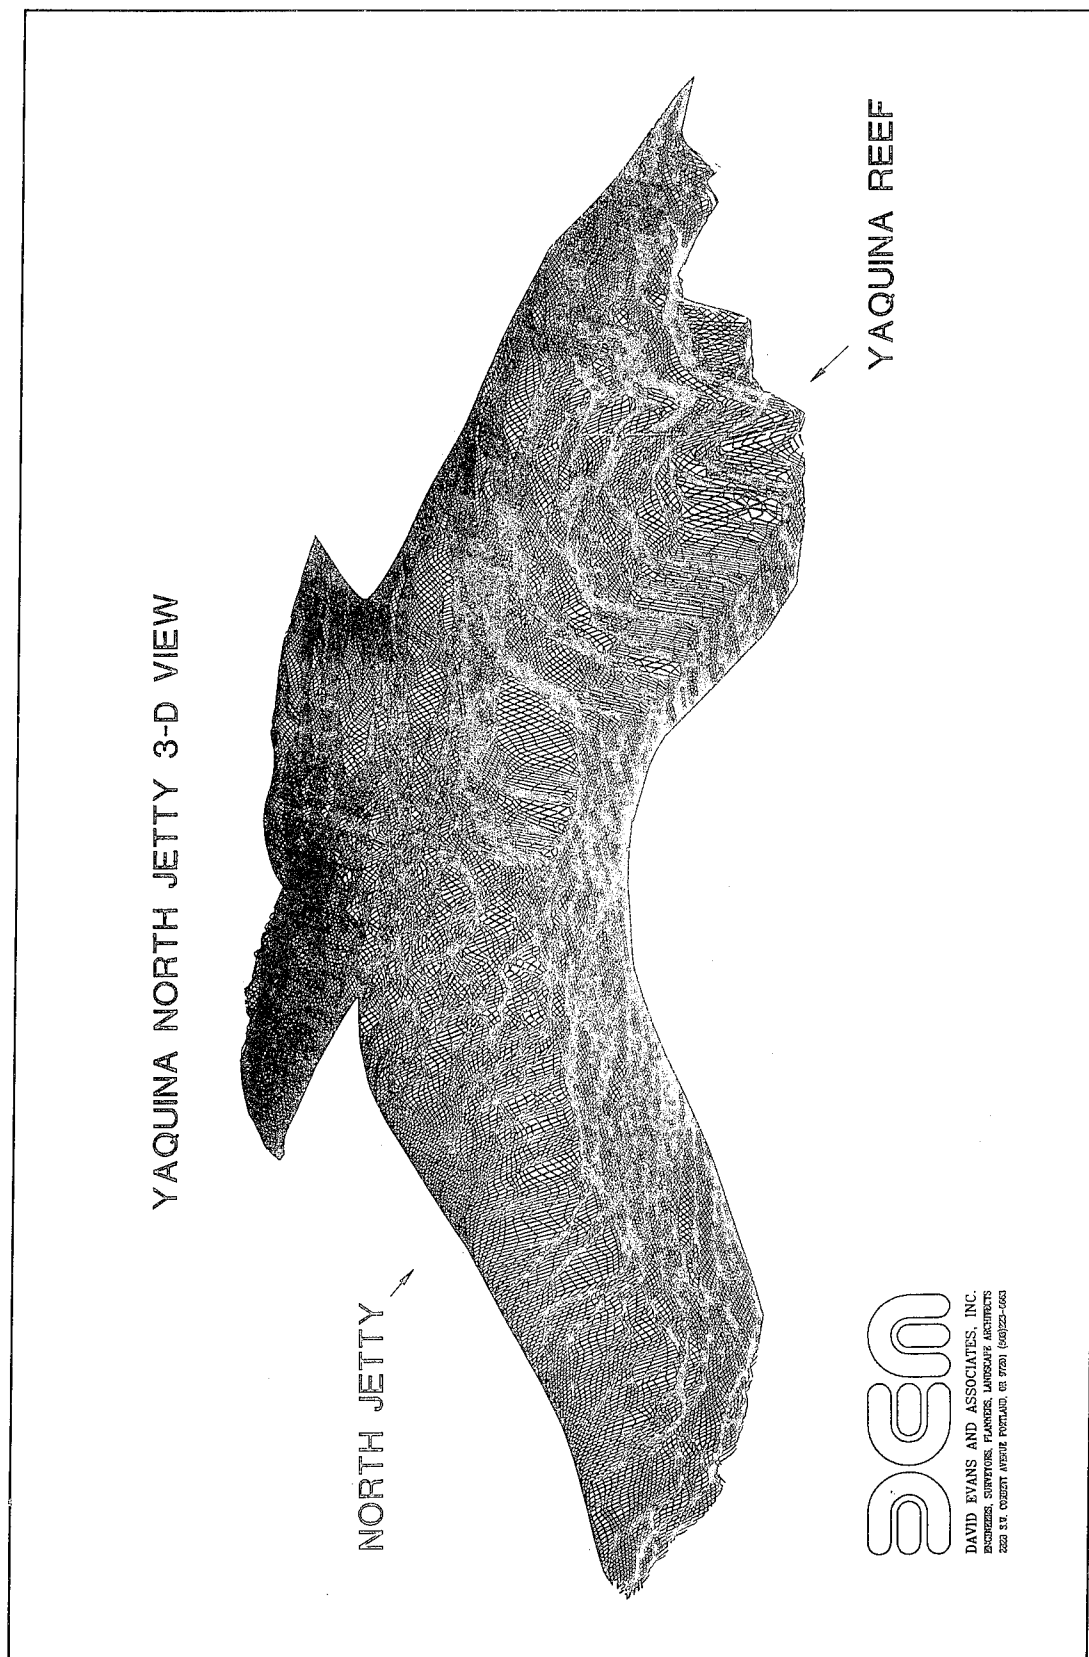
Figure 72. Orthographic "mesh" of Yaquina Bay north jetty and Yaquina Reef below-water bathymetry

Corrected elevation and position data from all the SEABAT tracklines were used in a digital terrain model to create a three-dimensional "mesh" of the seafloor, Yaquina Reef, and underwater portion of the north jetty covered by the survey. Figure 72 presents a view of this mesh from a perspective landward of Yaquina Reef and to the northeast of the north jetty tip. The north jetty is shown extending seaward from the left of the figure and intersecting with the reef. The smooth line to the top of the jetty mesh portion represents the uppermost limit of SEABAT data.

Note in particular on Figure 72 that the north jetty underwater slope becomes very mild toward the location where the jetty intersects with Yaquina Reef. This mild slope is assumed to consist of relic armor stone left from the last two rehabilitations. Also notice the very steep face on the landward side of Yaquina Reef. This reef formation could have significance in helping to direct longshore flowing currents seaward along the jetty.

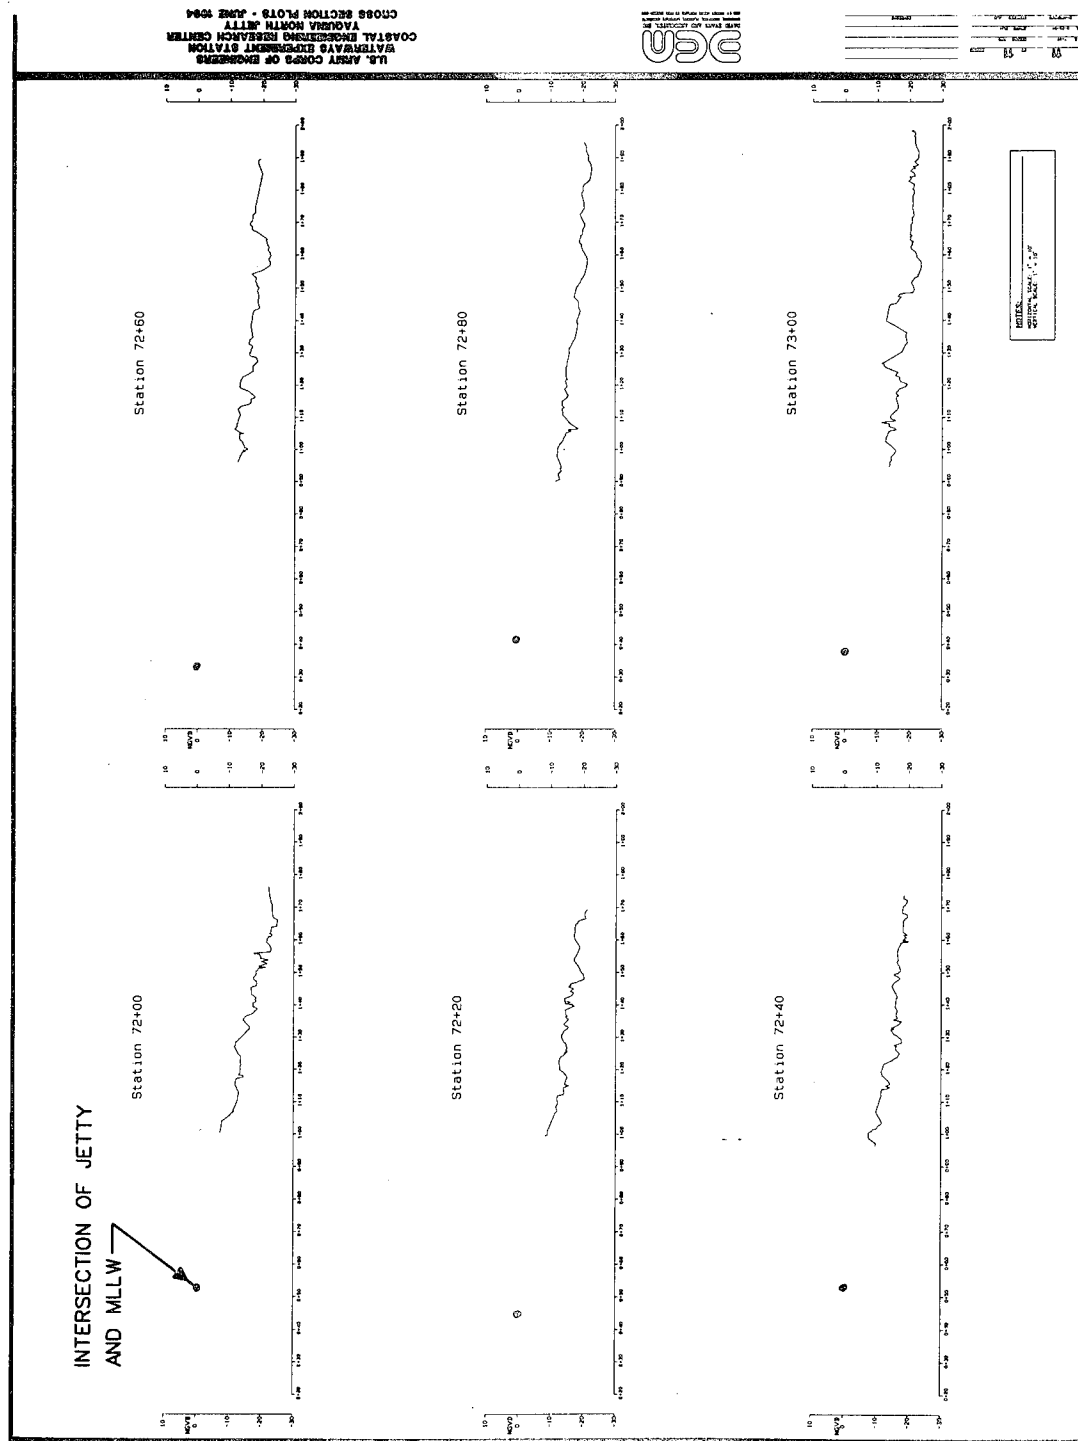
Figure 73. Underwater SEABAT profiles of the north side of the Yaquina Bay north jetty

The SEABAT elevation data were referenced to the same coordinate system used to display the photogrammetric elevation results for the above-water portion of the jetty. This allowed construction of cross-section profiles from the 0.3-x 0.3-m (1-ft x 1-ft) mesh grid that corresponded to selected jetty stations. Underwater profile cross sections for north jetty stations 72+00 through 73+00 are shown on Figure 73. The profiles are drawn at a scale that is only slightly distorted. The black dot drawn on each profile represents the approximate position of the north jetty profile at the mllw datum. The gap

between the dot and the profile is the region of the jetty that could not be surveyed by either photogrammetric methods or by SEABAT.
